Case Study on Shahberi Twin Building Collapse

Dr. Anshu Tiwari^{1*} Dr. Abhay Shrivastava²

INCIDENT

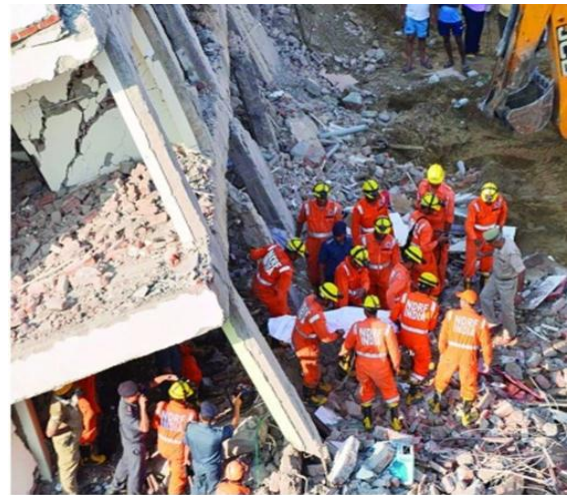
The building collapse incident happened in Shahberi village of Greater Noida on 17th July, 2018 around 9:30 p.m. There were two buildings, 4 storey completely constructed building was two year old, and another was 6 storey under construction. The buildings stood next to each other on the marshy land and were separated by a 5 feet wide road.

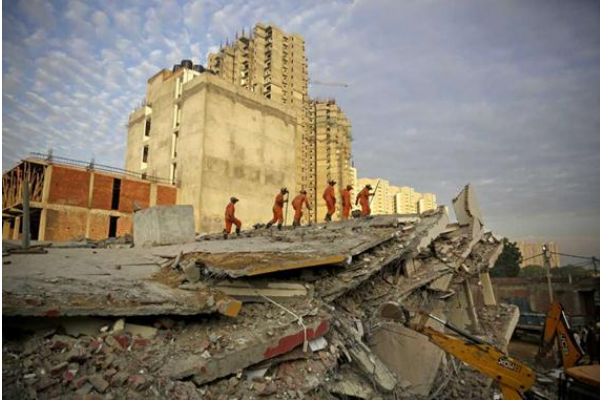
The building under construction tilted into the older building, whose left side was the first to cave in and crumble into rubble due to water logging in foundation and too much of moisture in the walls of the basement of the collapsed buildings. The older building also disintegrated and caved in, barring a part of its right edge. One fell in pancake form and the other tilted to its side. Beams and slabs fell on the occupants of the building, sandwiching people and leaving all the occupants dead. Some bodies were pierced by iron rods and concrete and other were trapped under several layers of concrete. In all, 9 people died being trapped in the debris.

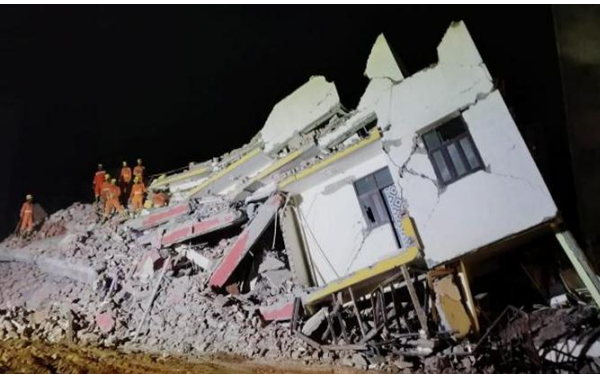
The twin buildings collapsed due to unapproved construction going on at that site. Local residents mentioned that the place where collapse has taken place had some water body which was filled to construct residential flats. The land of this area is not hard enough to withstand heavy construction and in absence of proper system of disposal of sewage and garbage the soil has become swampy because of water logging resulting weakening of foundation of building. Most of the buildings in that area are over five-storey and that too in water inundated land. Unplanned construction is rampant in the area over stepping all safety norms. The construction took place without any design by qualified engineers and reinforced concrete-framed structure.

The other reason for collapse was that the construction is done with the sub-standard building material including fly-ash bricks and pillars developing cracks even before any substantial construction took place. And the moment six-storey under-construction building collapsed on fully constructed and occupied adjacent building, it leads to a complete fall.

- The constructed/under-construction building should be surveyed from hazard and vulnerability point of view.
- A strict action should be taken instantaneously on illegal/unauthorized construction to avoid the incidents.
- Concerned authorities should check the licence and approved plans before any construction take place by builders.
- Officers who overlook everything should be held responsible and strict action should be taken against them.
- The builders should not get benefitted by the lack of administrative action.
- The blind eye of administration against the complaints lodged regarding illegal construction encourage builders to use

- Strict measures needs to be implemented for encouraging the builders/owners to follow NBC codes like soil testing, construction material etc.
- Structural audit of building should be done by the competent authorities. Unauthorized construction needs to be taken up as a punishable offence.
- Strict action should be taken against those involved in illegal constructions.
- Accountability of officials should be fixed who are violating the rules and they should be booked.
- The accountability of civil engineer and architect need to be fixed for the construction quality of building along with the builder.
- Occupancy without compliance should be made punishable.
- State Disaster Response Force should be equipped with necessary equipments to act as first responders which can be discussed with NDRF.
