Consideration of Events, Measures and Reasons of Disaster in Himalaya

Sachin*

M.Phil. Scholar, Department of Geography, MDU Rohtak

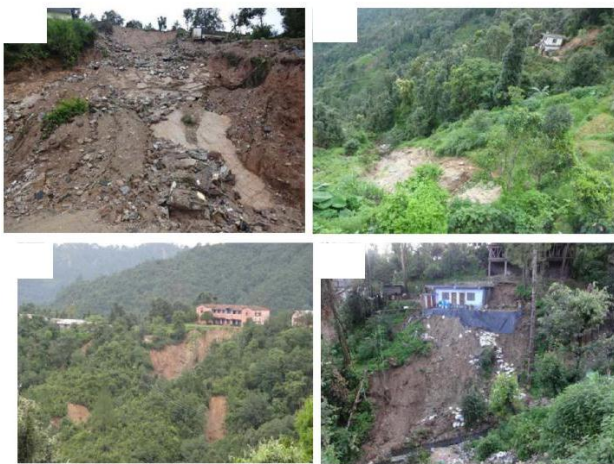
The landslide is found just beneath the Didihat-Adichaura motor road that is involved by outcrops just as thick overburden. Because of heavy rainfall a noteworthy landslide occurred in Ambedkar ward and Deendayal Park was severally damaged. This slide has somewhat damaged two houses to its left side and right flanks and these are under extreme risk (Figure 2a). Furthermore, a few houses in Shiv Mandir and Tehsil Wards were likewise influenced via landslide incidences (Figure 2b and 2d). Debris slide is situated close District Institute of Education and Training (DIET), Didihat. Directly, Govt. polytechnic is led in a structure of DIET, arranged simply over the landside (Figure 2c).

Figure 2: Landslide incidences in the region around Didihat damaged Deen Dayal Park at Ambedkar Ward

(a), slope disappointment in back and front of certain houses at Shiv Mandir Ward (b), debris slide in front bit of District Institute of Educational and Training (DIET) at GIC Ward (c) and mass movement in front piece of house at New Basti zone in Tehsil Ward (d).

- a. It is suggested that all current or proposed retaining and different dividers, and some other covers on slopes, must have proper game plans to permit free drainage of slope material with the goal that destructive pore pressures don't create in the slope.
- b. It is prescribed that as the space among slope and house is less, secured solid shade divider must be considered at the equivalent.
- c. It is suggested that the rock fill buttress or gabion divider can be given to secure the totally weathered rock/soil slopes.

- d. It is suggested that the low retaining dividers at various dimensions of the slope with free draining backfill, to help the fill around structure.

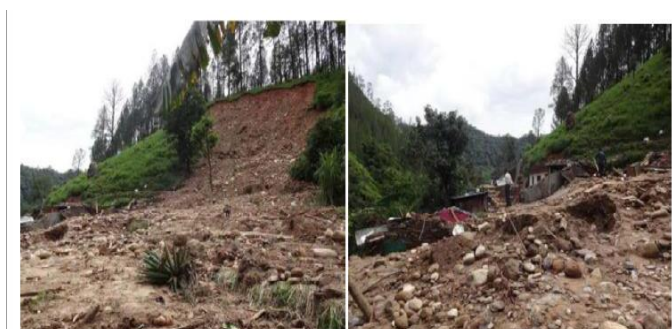
Heavy rainfall additionally quickened gulley erosion on river born material (RBM) and debris stream occurred at Kumalgaon (close Naulra village) too. 3 people were killed in this incidence while places of 5 families were buried under the debris. Around 70 creatures were lost in the incidence. 2.5-3.0 m thick heap of debris was seen at the site. Presence of river born material (RBM) is seen behind the home. Slope at this area is seen to dip towards east at an angle of around 40°. Signs of heavy rainfall incited gulley erosion and debris stream are seen amid field examination.

RBM is constantly powerless for the slope disappointment because of the roundness of its constituents and poor union. The debris slide is seen to have happened on the eastern slope of N-S drifting edge. The width of the disappointment slope is around 50 meters along the developed

The landslide debris that plunged down from the area upslope of the village is seen to have invaded both rural fields and houses (Figure 4a and 4b). The thickness of the debris aggregated in the area is seen to be around 3.0 meters. This overburden material is seen to contain river borne material comprising of dark brown to ruddy, fine grained silty-sandy matrix with adjusted boulders and rocks.

Figure 3: Debris flow on slope made up of RBM at Kumalgaon near Naulra village (a) and devastation around Kumalgaon village (b).

The landslide is derived to be very helpless to disappointment, especially in case of heavy or delayed rainfall. Geologically, the area is found to be in a basic condition of harmony and the accompanying suggestive measures are proposed:

- The occupants are consequently encouraged to be careful distance from the vulnerable slope and clear the area, particularly amid heavy or delayed rainfall
- During field examination it was seen that the devastation for the most part happened along areas where Quaternary deposits were available.

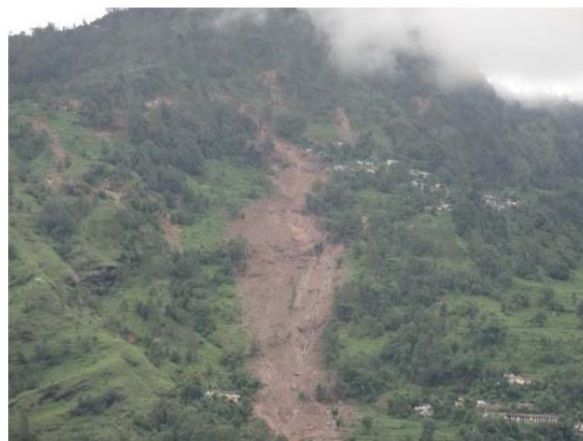
The slope in the territory is commonly watched dip towards southwest at soak angles (55-60°). This has encouraged quick downslope movement of debris. Various farming fields alongside houses were in this manner damaged because of debris streams in the Bastari territory (Figure 3). The thickness of the debris gathered in the region is seen to be around 3.5 to 4.0 meters. This material is seen to involve hill wash and debris comprising of darker, fine grained silty-sandy matrix with uncommon rocks and pieces of granitic gneisses.

Figure 4: View of Bastari debris flow

- The hill slope around Bastari village is concluded to be profoundly vulnerable to disappointment, especially in case of heavy or delayed rainfall. The inhabitants are in this manner encouraged to be careful distance from the vulnerable slope and abandon the area, particularly amid heavy or delayed rainfall.
- It is very imperative to guarantee every single future construction just on firm ground. In the meantime, excavation on soak slope ought not be permitted. The exhumed slope whenever left untreated is certain to present risk amid heavy rainfall.

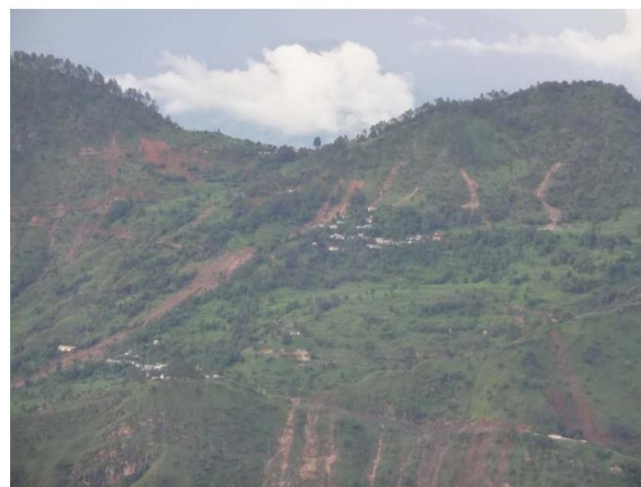
Figure 5: Landslide scars developed after heavy rainfall around Bastari village.

landslide a few landslide scars are additionally seen on the uphill side to Bastari village. Enactment of these has the capability of presenting threat to the village. Geologically, the area is found to be in a basic condition of equilibrium and the accompanying suggestive measures are proposed:
