Health Monitoring of Mundhwa Bridge

Site location: Mundhwa Bridge over Mutha River, Pune.

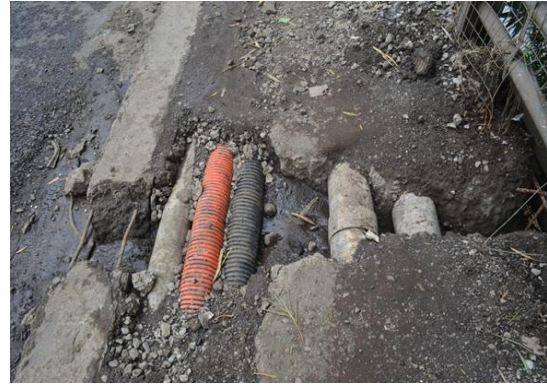
- [f] Utilities: There is a pipe line passing from the centre of the bridge. Which also acts as a median. Pipe line has leaked and this has cause several damages, it is therefore advisable to have arrangement at the joints in pipe to collect leaking water & let it be released out. In the pipe line there is one expansion joint, gap for expansion does not appears to be adequate. There is another service line going over the footpath which is not covered. A service line is passing outside the railings, fixed to the bridge by steel brackets.

Image-(b): service lines in footpath are not covered

- [2]. Replace the bearings by POT-PTFE bearings as RCC roller rocker bearings are not permitted by MORTH, since many such bearings have cracked.
- [3]. All expansion joints are to be replaced by strip seal expansion joints.
- [5]. The kerb should be replaced by M25 concrete RCC kerb and 75mm thick flooring of M35 concrete is to be provided over the footpath. Better to accommodate services in footpath zone. Tiles should be provided on the footpath.
- [6]. A cover should be provided over the water spouts and a pipe projecting from there is required at all water spout locations.
- [7]. The service line going over the footpath should be covered.

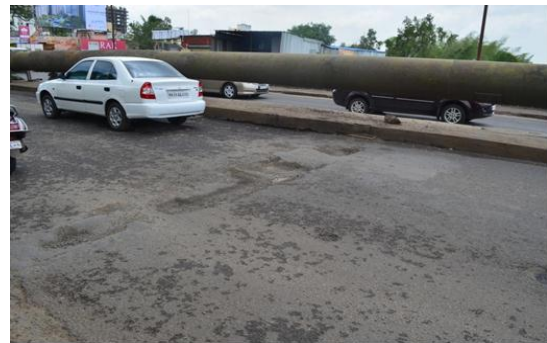
- [d] Footpath: The kerb at the footpath is damaged.
- [e] Expansion joints: Concrete at the expansion joint is deteriorated. Whenever the vehicles travel over the bridge, a thudding sound coming from the expansion joints & bearings indicating upward or downward or longitudinal movement, due to movement of joint. It is not merely a sliding phenomenon. The vertical movement is more prominent. Initially the steel railing was continuous over the joint later the pipes were cut to make a joint at expansion gap. In the service pipe line there is one expansion joint, gap for expansion does not appears to be adequate.

Image-(c): Expansion joint are to be damaged

- [1]. The width and the span being equal there is expansion and contraction in central and longitudinal direction, however the bearing and expansion gaps are designed only for longitudinal direction. It is therefore necessary to provide such type bearings and expansion joints which can move in both directions i.e.

lateral and longitudinal. POT-PTFE bearings and strip seal expansion joints are ideal for such situations.

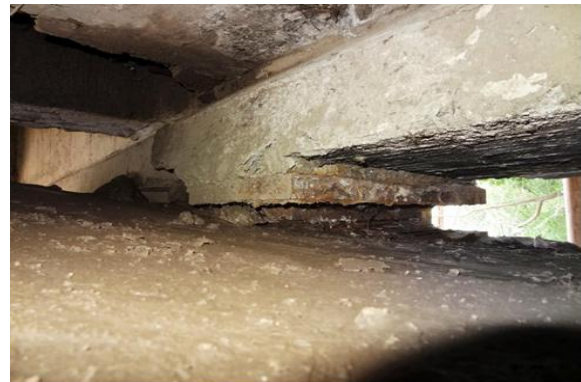
RCC roller rocker bearings are provided. The bearings are in very poor condition.

Image-(d): Damaged bearing

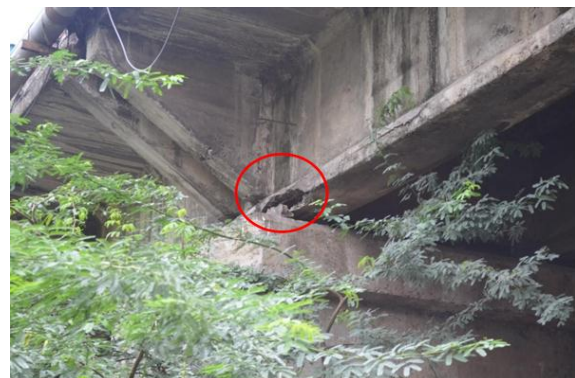
Image- (e): damage to the structure at bearing location

Sr. No.	location	member	Distance mm	Time micro sec	velocity
1	Damage bearing location	RCC girder	245	57.2	4.28
2	Damage bearing location	RCC girder	245	67.2	3.65
3	Damage bearing location	RCC girder	400	104.7	3.82
4	Damage bearing location	RCC girder	500	121.8	4.11
5		RCC girder	400	110.7	3.61
6		RCC girder	220	49.8	4.42

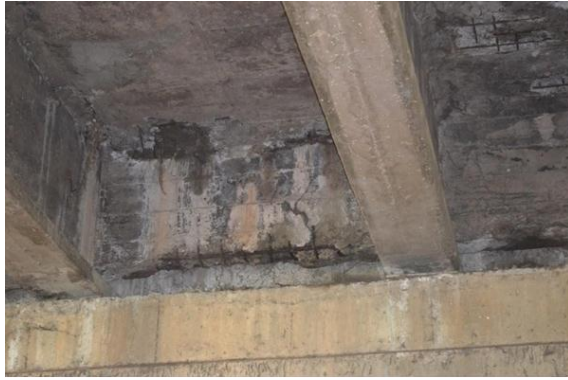
Image- (f): Damage in deck slab, steel is open in slab
