The survey and representation for the safeguard of the cultural heritage in case of emergency

Abstract - In this short article we aim to describe the strategy and technique used to survey the Church of Sant'Andrea in Campi di Norcia, which was severely damaged by the 2016 earthquake. The church stands at the entrance of the village, in a position of relevant importance for the landscape of the Val Castoriana, on which the village overlooks. Therefore, considering the framework of damage suffered by the building and its position with respect to the access system of the village, the main objective was to secure the space surrounding the building, aiming to counteract movements of the decks and strengthen the damaged elements, to prevent further collapses. After the securing of the building, it was possible to proceed with the survey campaign. We describe the difficulties encountered due to the presence of rubble and the elements to secure the building, stressing that the survey of cultural heritage, especially in the field of property destroyed by the earthquake, is one of the most representative scenarios in which to use and test modern detection techniques. In fact, recent digital

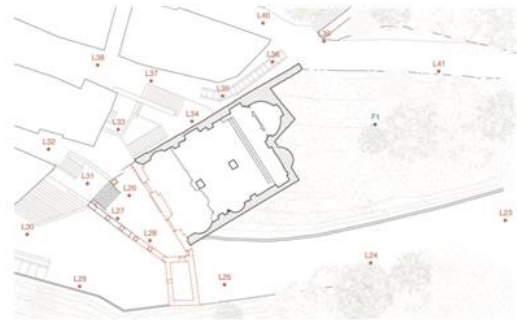
Keyplan of the scans performed with Leica P40 and Faro X330 laserscanners

Then, it was necessary to establish the position of the survey stations to avoid the so-called "shadow cones", areas without points due to the projection of protruding or recessed parts on the surrounding surfaces, and to set the scans to be made. The 360° scans with an average density of points were flanked by very high-density scans for smaller areas that were particularly difficult to reach or with more complex geometries. These scans were carried out with two different scanners: the Leica P40, used for the 360° scans both inside and outside, and the Faro X330, lighter and more manageable, useful for the scans inside the bell tower and for those to be set at levels raised above the floor.

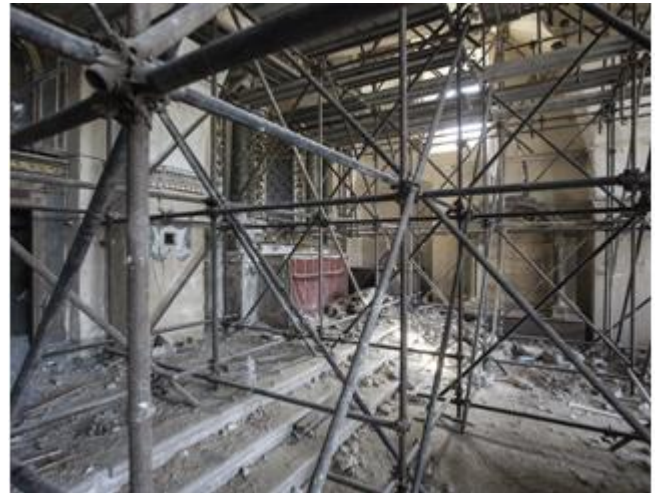
Church of Sant'Andrea in Campi di Norcia; the presence of rubble and securing made laser scanner survey operations difficult.

The survey campaign was carried out taking into account the considerable difficulties of the site. The presence of rubble made some scans largely incomplete, especially near the collapsed span. Moreover, the securing of metal structures inside the building made the movements of the operators difficult and increased the number of stations necessary for a complete restitution. The same securing has also made necessary a long cleaning phase of the scans, in order to eliminate these structures. The reading of the "cleaned" model results however of difficult readability.

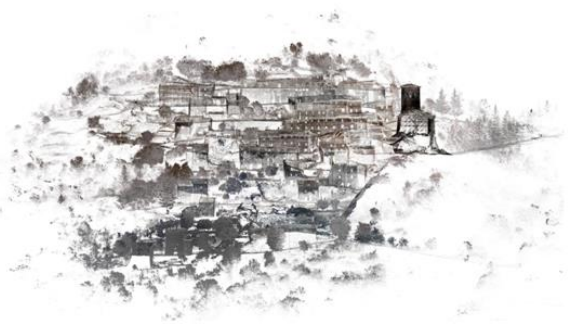
View of the town of Campi di Norcia. The elaborate has been obtained from the union of the scans made with the Leica P40 laser scanner
